Norfolk Southern Railway Multitrain Collision and Derailment

Location	Easton, Pennsylvania
Date	March 2, 2024
Accident type	Multitrain collision and derailment
Eastbound striking train	Freight train NS268H429 2 crewmembers 2 locomotives, 39 intermodal railcars
Stopped train	Freight train NS24XH101 2 crewmembers 3 locomotives, 27 intermodal railcars
Westbound striking train	Mixed freight train NS19GH501 3 crewmembers 3 locomotives, 199 mixed manifest railcars
Track	Main track, signalized
Hazardous materials	Ethanol residue and butane residue
Fatalities	0
Injuries	4
Damages	\$2.5 million

Summary

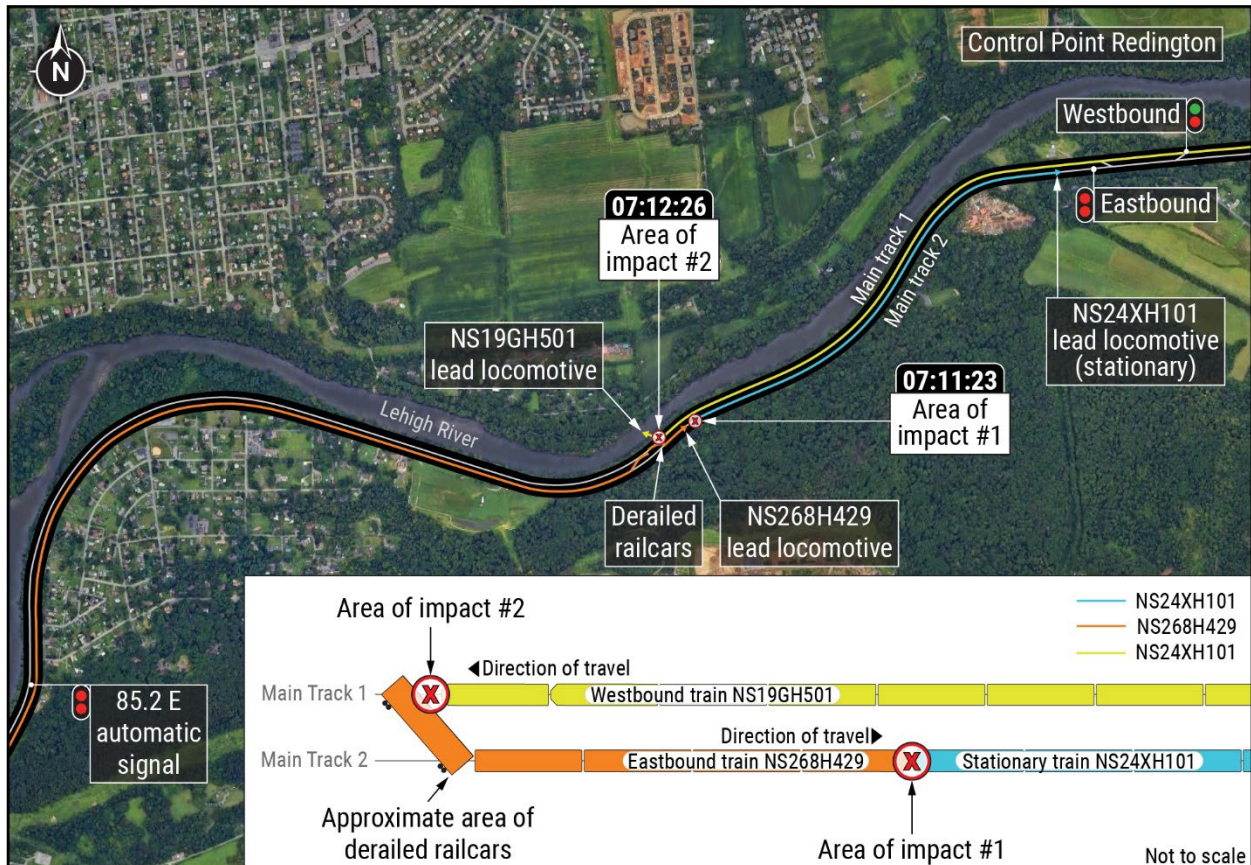
placarded as hazardous materials tank cars: one containing ethanol residue and two containing butane residue.³ The tank cars did not breach or release hazardous materials. The two derailed locomotives partially submerged in the Lehigh River and discharged locomotive diesel fuel into the water. (See figure.) Four crewmembers from the accident trains were transported to a local hospital, treated for minor injuries, and released. At the time of the collisions, visibility conditions were daylight and overcast; the weather was 35°F with light rain.

Figure. Graphic showing aerial view of train routes and derailment illustration. (Source: Google Earth.)
