Railroad Investigation Report RIR-25-11

Middlesex Corporation Employee Fatality on Housatonic Railroad Company-Operated Line

Great Barrington, Massachusetts
August 4, 2023

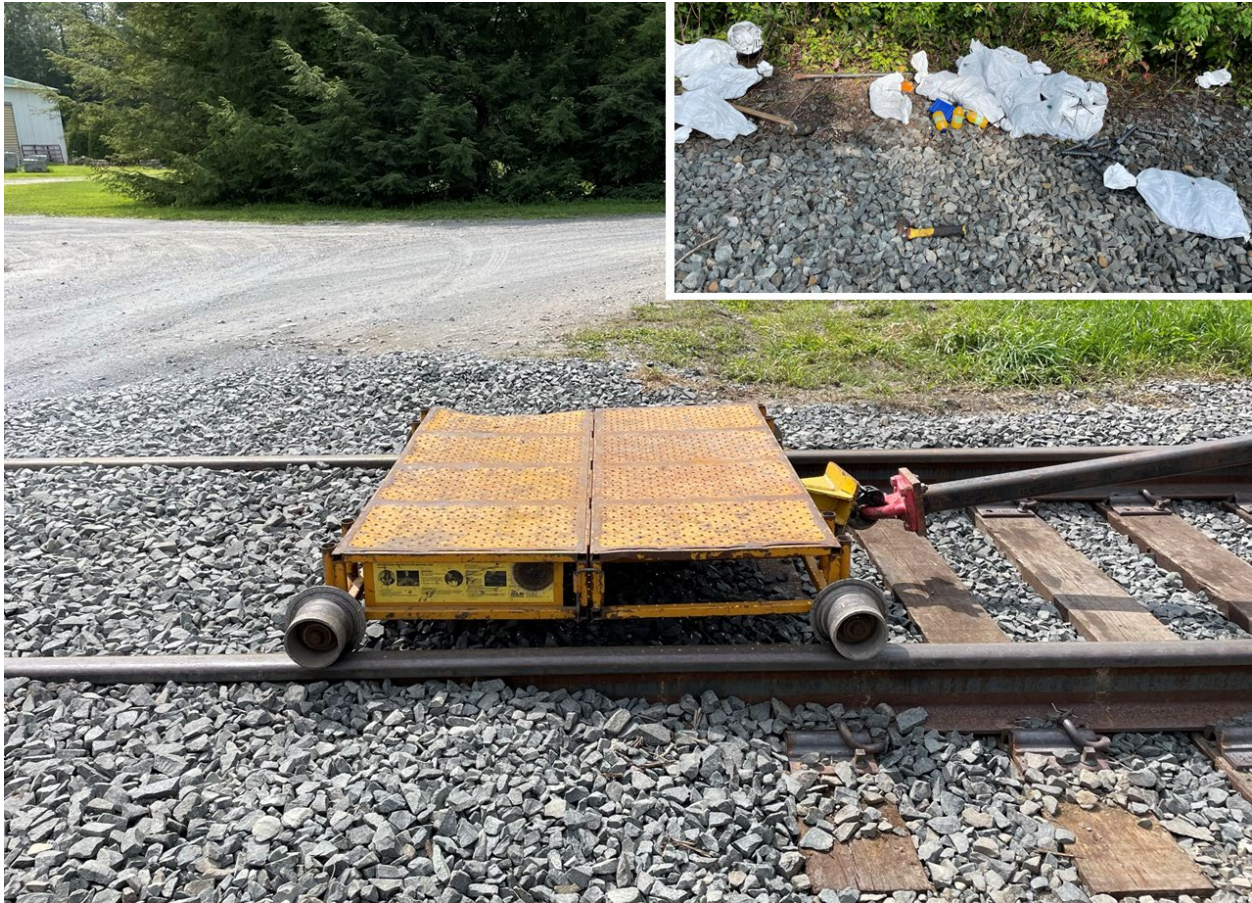
Figure 4. The rail cart struck by the driller.

Employee 1 fell to the ground between the rails when he was struck by the driller. The driller passed over the employee and struck the rail cart. When the driller came to a stop, employee 1 was in front (south) of it. (See figure 5.) The work group immediately called 911, contacted supervisors, and assisted emergency responders with accessing the accident location. First responders transported employee 1 by helicopter to Baystate Medical Center, where he was later pronounced dead.

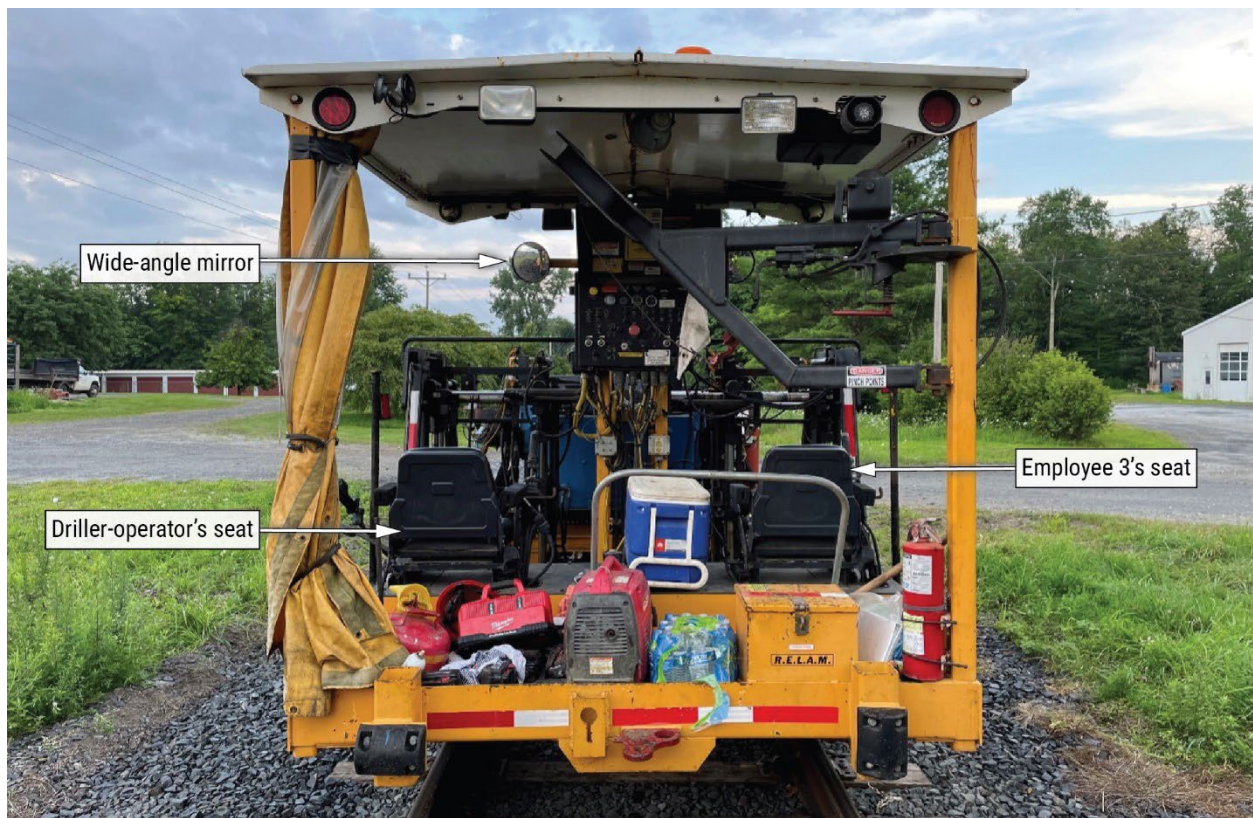
Figure 6. Rear view of the tie driller RMM. (Courtesy of the FRA).

The driller was not equipped with rearview cameras and monitors or any other technologies, such as a collision avoidance system that could have assisted the operator in detecting employees in the driller's path or that could have automatically stopped the RMM before a collision.⁹

The NTSB concludes that the use of collision avoidance systems on RMMs can save lives by automatically intervening to prevent an impending collision when an operator does not act to stop an RMM movement. The NTSB recommends that the FRA require all on-track RMMs to be equipped with collision avoidance systems that can detect people, objects, or other machines on the ground and automatically stop the RMM before a collision.

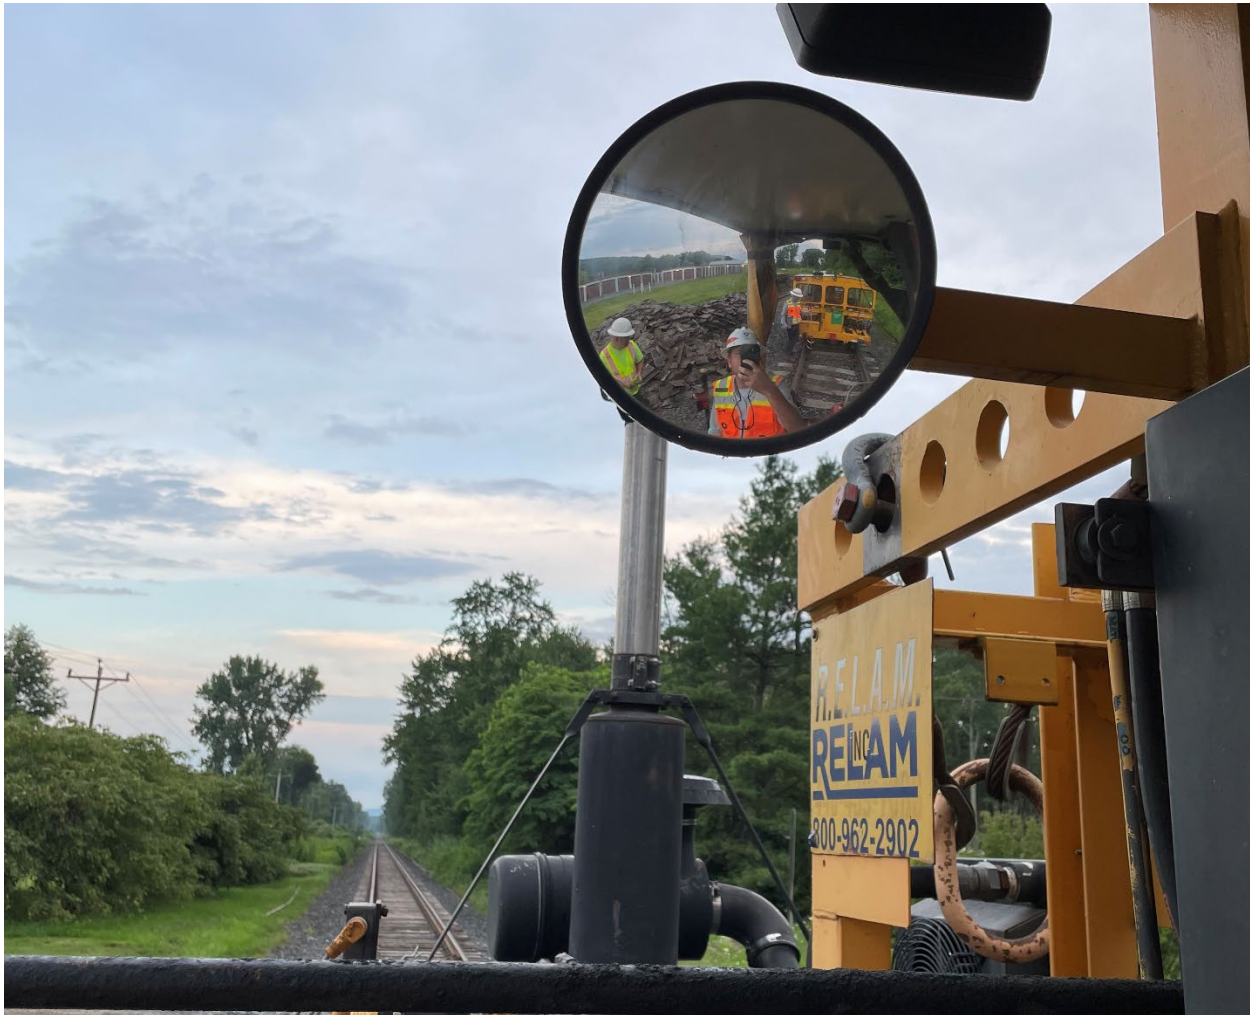
Figure 7. The field of view in the driller’s rearview wide-angle mirror from the driller operator’s seat. (Courtesy of the FRA.)

the operator or employee 3 could have observed the driller's direction of travel using the small, wide-angle mirrors visible from their seats when facing forward, though objects or people in their path would be seen more quickly and easily by turning to face the direction of movement.

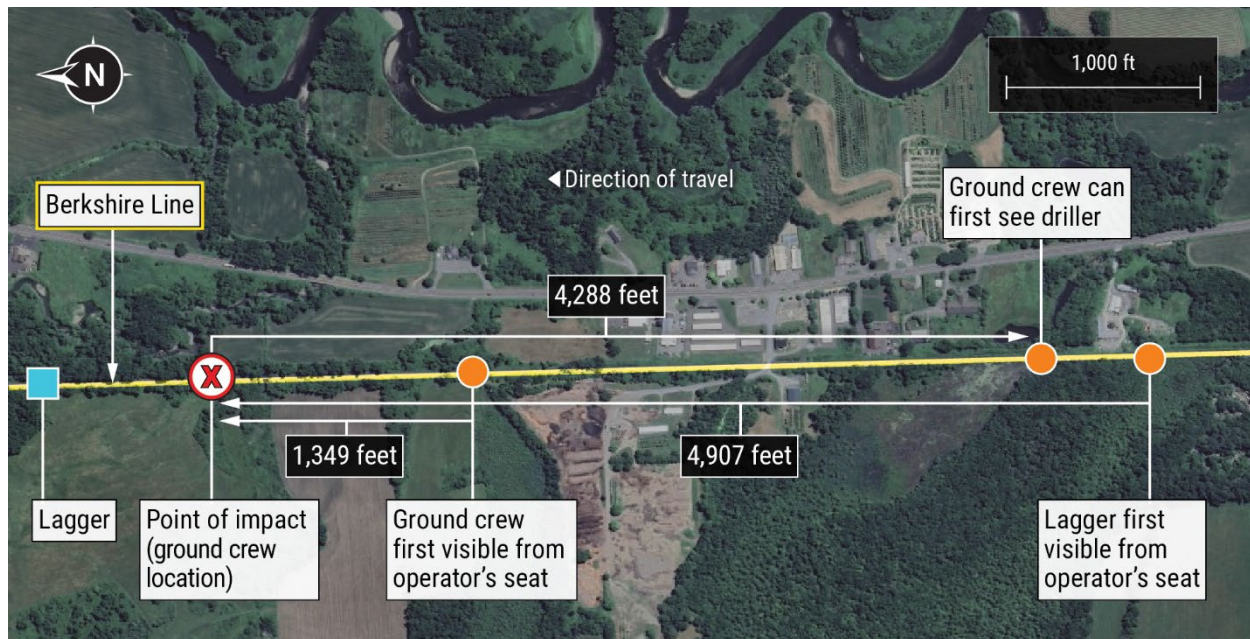
Figure 9. Sight distance observation results. (Background image courtesy of Google Maps.)

- The investigator could first see the stationary lagger from either of the two seats in the driller when the driller was about 4,900 feet from the point of impact.
- Investigators on the ground at the point of impact could first see the driller when it was about 4,300 feet away.
- The investigator in the driller could first see the investigators on the ground from either of the two driller seats when the driller was about 1,300 feet away.
